## **TAMU Project**

**Energy Consumption Data Quality Assurance/Quality  
Control Assessment Report for the  
Month of October 2017**

**Utility & Energy Services  
Division of Administration  
Texas A&M University**

**November 2017**

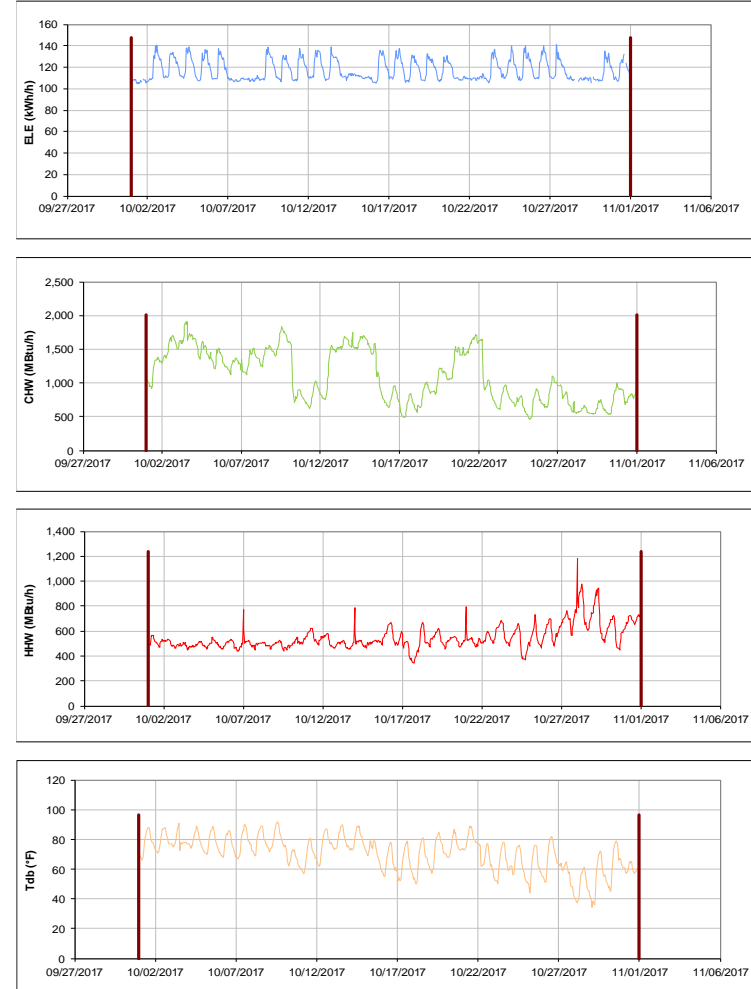
TAMU / BLDG #: 1525

Figure III-170 Hourly Whole Building Electricity, Chilled Water, and Hot Water Consumption for Nuclear Magnetic Resonance Facility during the Month of October 2017 and the Corresponding Hourly Outdoor Dry Bulb Temperature for College Station, TX

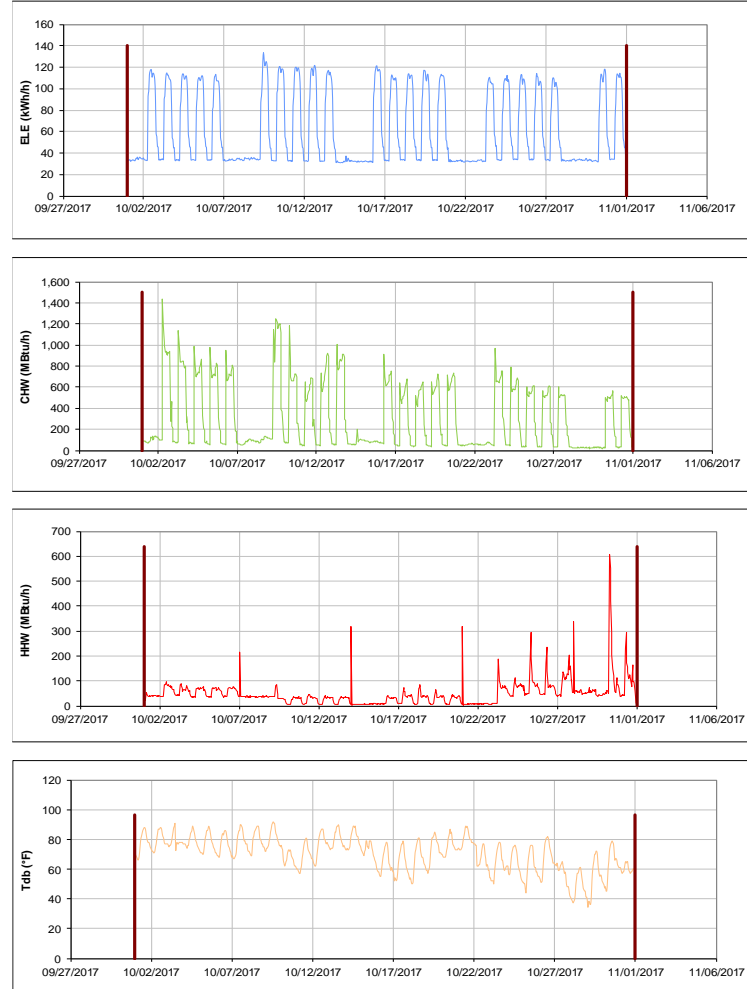
TAMU / BLDG #: 1536

Figure III-173 Hourly Whole Building Electricity, Chilled Water, and Hot Water Consumption for AgriLife Services Building during the Month of October 2017 and the Corresponding Hourly Outdoor Dry Bulb Temperature for College Station, TX

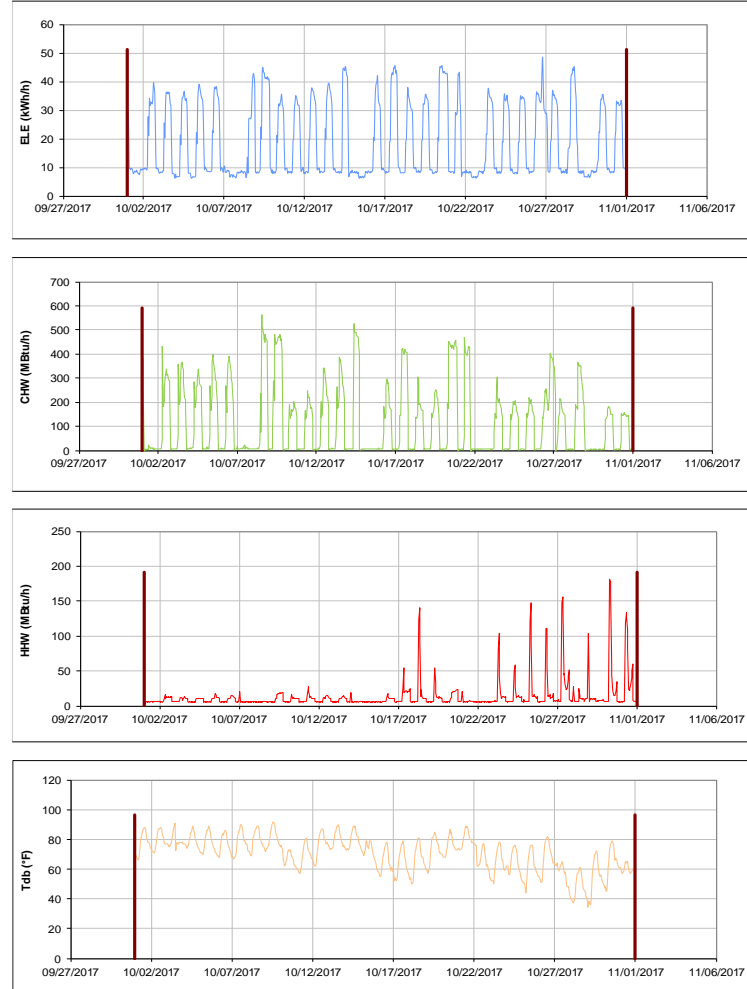
TAMU / BLDG #: 1538

Figure III-175 Hourly Whole Building Electricity, Chilled Water, and Hot Water Consumption for Agriculture Program Visitors Center during the Month of October 2017 and the Corresponding Hourly Outdoor Dry Bulb Temperature for College Station, TX

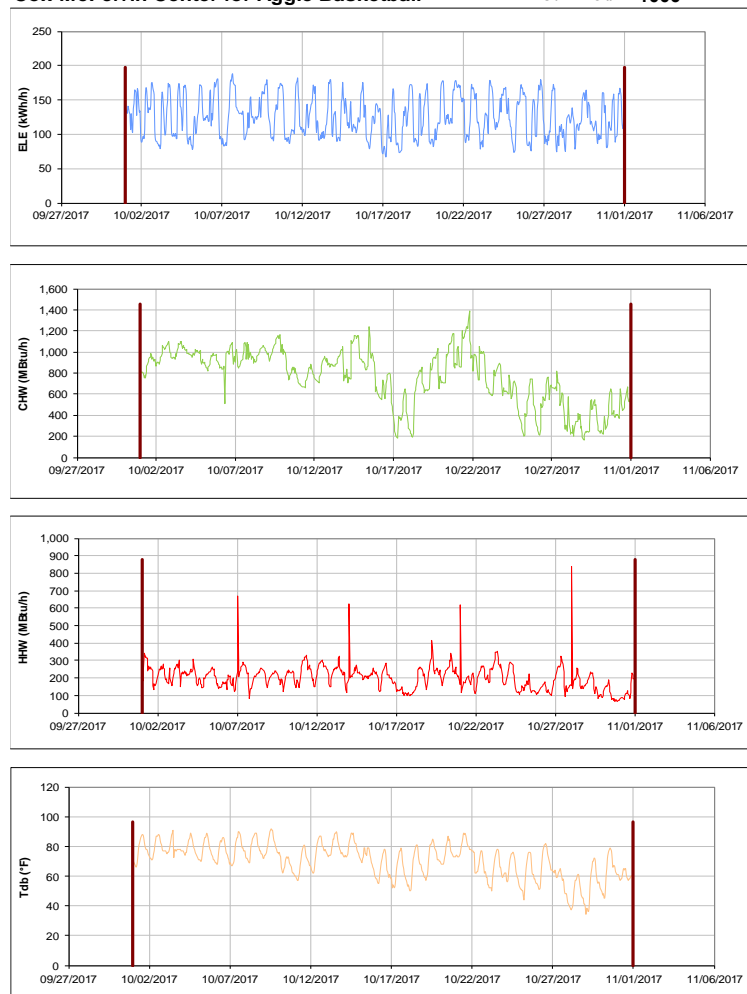
TAMU / BLDG #: 1558

Figure III-181 Hourly Whole Building Electricity, Chilled Water, and Hot Water Consumption for Cox-McFerrin Center for Aggie Basketball during the Month of October 2017 and the Corresponding Hourly Outdoor Dry Bulb Temperature for College Station, TX

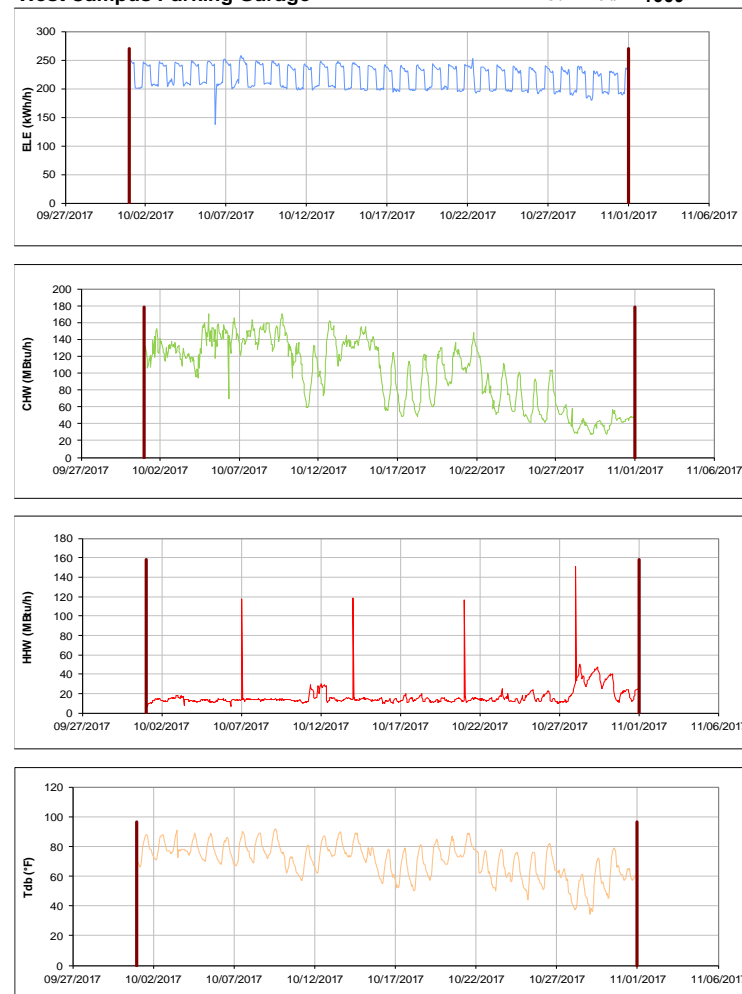
TAMU / BLDG #: 1559

Figure III-182 Hourly Whole Building Electricity, Chilled Water, and Hot Water Consumption for West Campus Parking Garage during the Month of October 2017 and the Corresponding Hourly Outdoor Dry Bulb Temperature for College Station, TX

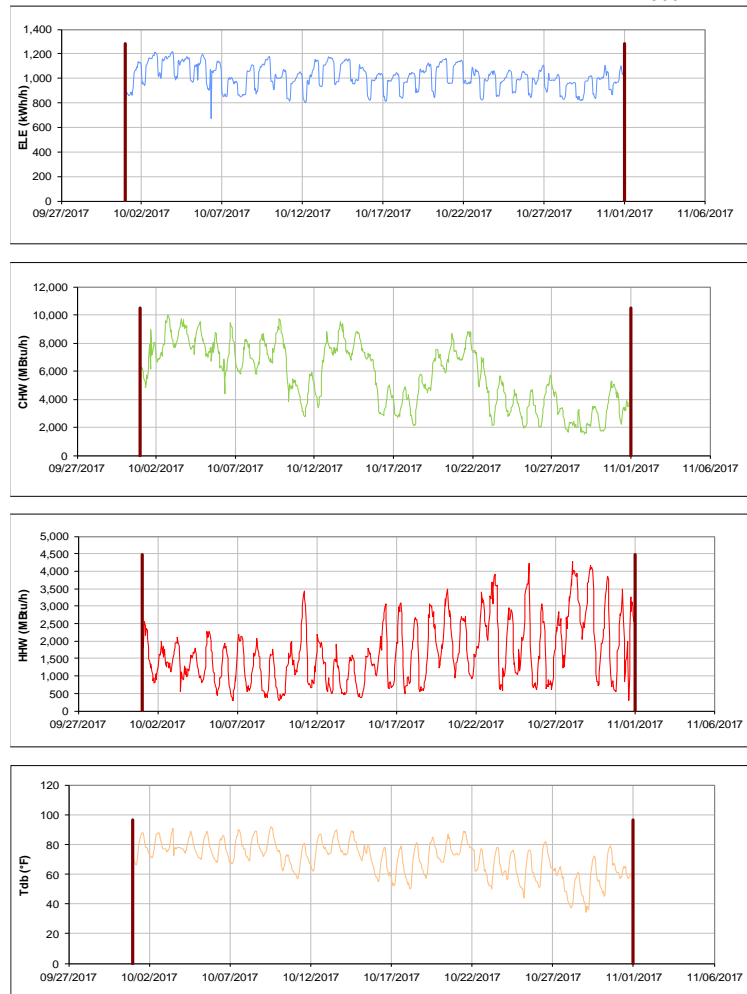
TAMU / BLDG #: 1560

Figure III-183 Hourly Whole Building Electricity, Chilled Water, and Hot Water Consumption for Student Recreation Center during the Month of October 2017 and the Corresponding Hourly Outdoor Dry Bulb Temperature for College Station, TX

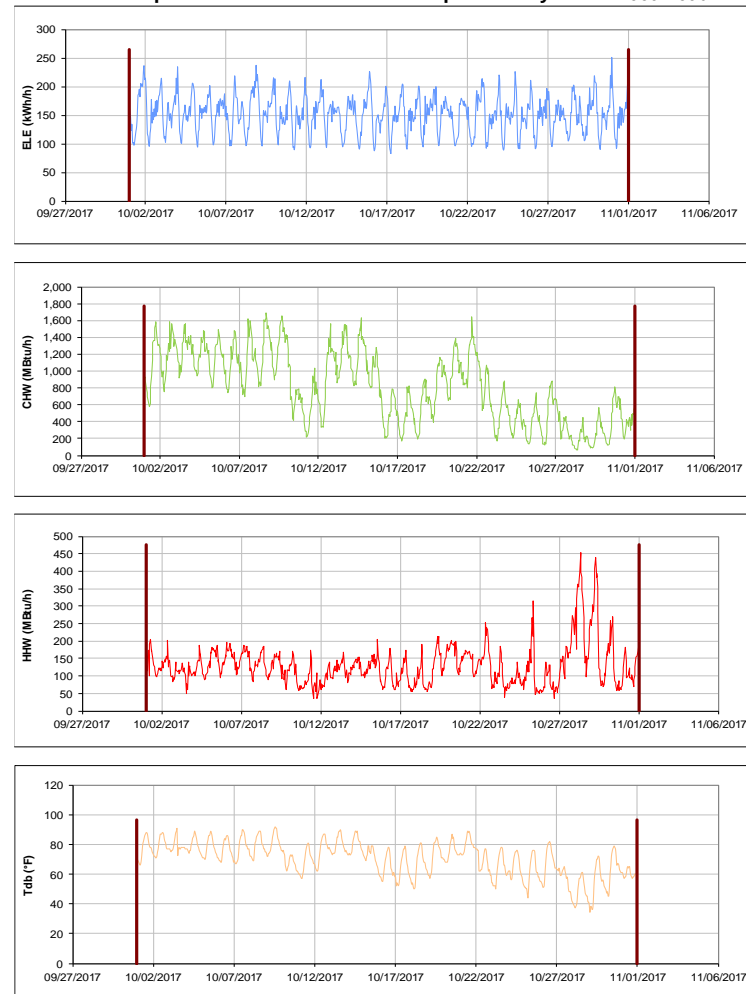
TAMU / BLDG #: 589-1590

Figure III-184 Hourly Whole Building Electricity, Chilled Water, and Hot Water Consumption for White Creek Apartment 1 and White Creek Apts Activity Center during the Month of October 2017 and the Corresponding Hourly Outdoor Dry Bulb Temperature for College Station,

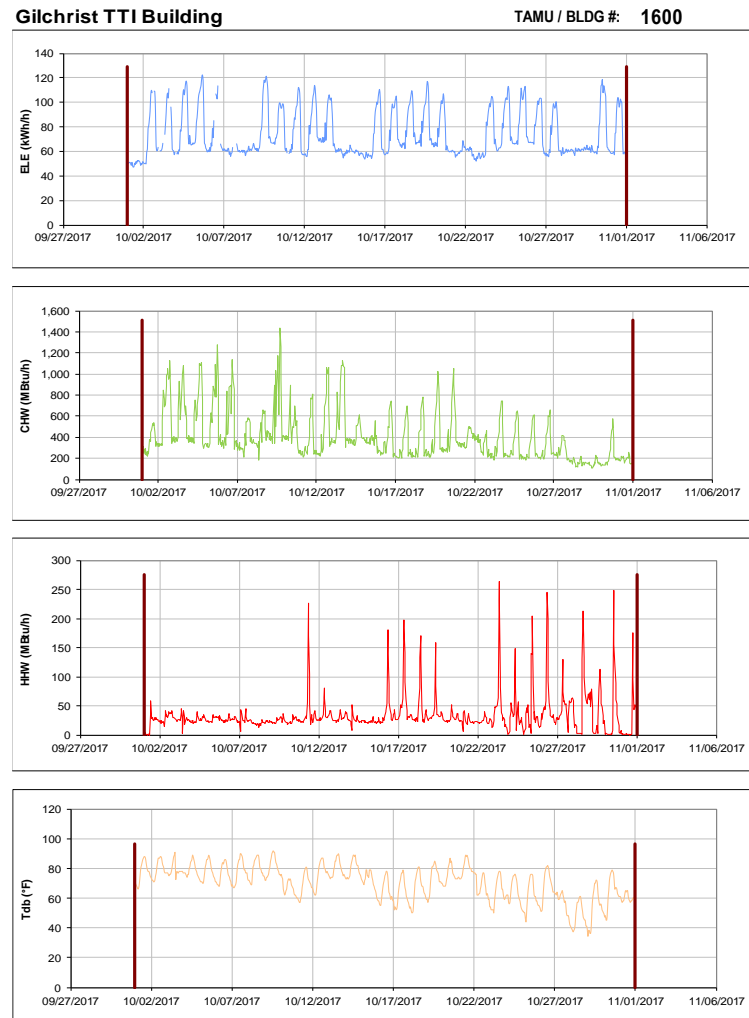
Figure III-187 Hourly Whole Building Electricity, Chilled Water, and Hot Water Consumption for Gilchrist TTI Building during the Month of October 2017 and the Corresponding Hourly Outdoor Dry Bulb Temperature for College Station, TX

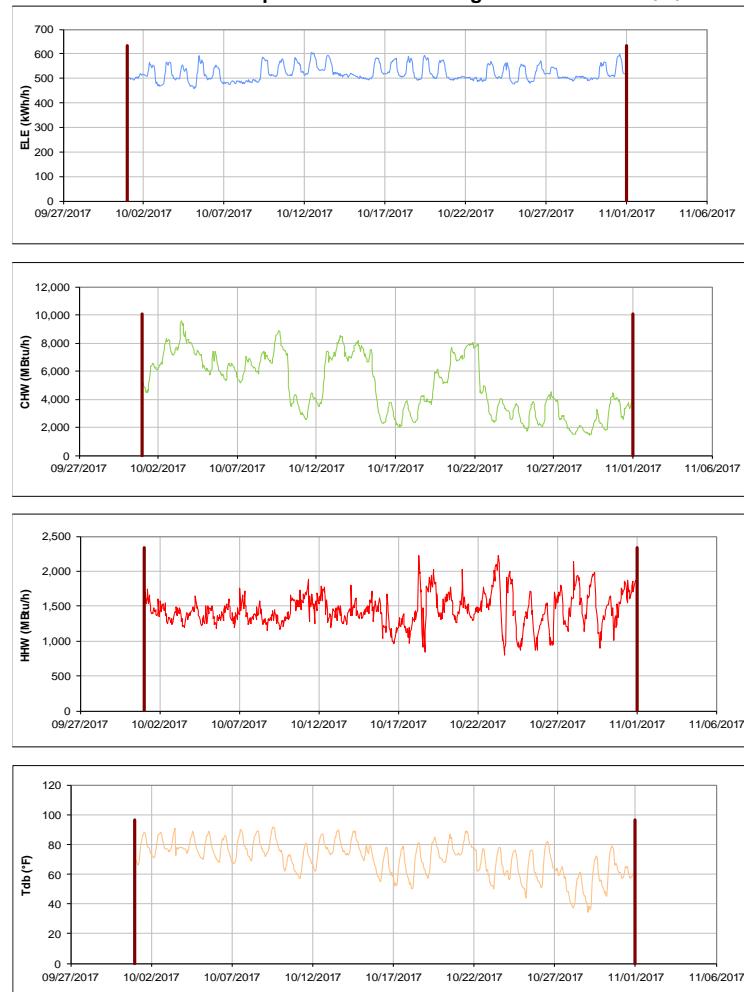
**National Center for Therapeutics Manufacturing** TAMU / BLDG #: 1910

Figure III-202 Hourly Whole Building Electricity, Chilled Water, and Hot Water Consumption for National Center for Therapeutics Manufacturing during the Month of October 2017 and the Corresponding Hourly Outdoor Dry Bulb Temperature for College Station, TX
